Manhole Inspection Summary

Manhole # S23M__016MH

Insp Date: **6/18/08 8:05 AM**

Location Address: **512 S Gilmore St**

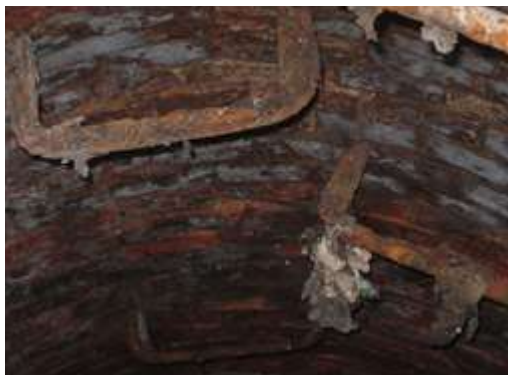
Defect 3

Count: **6** Missing: **0** ☒ **Corroded**

☒ **Evidence Of Surcharge** Depth: **5** (ft.) ☐ Active Surcharge Present

corroded rungs,evidence of surcharge on steps

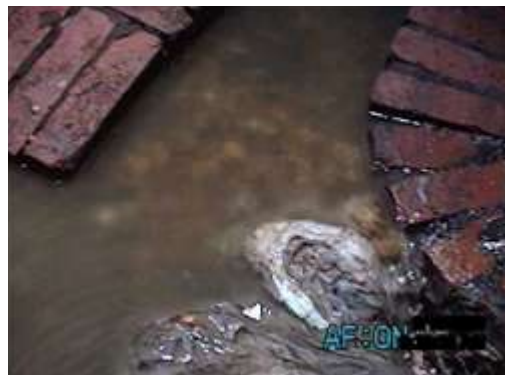
Defect 4

Condition: ☐ Sound ☐ Cracked ☐ Root Intrusion ☐ Deteriorated ☐ Leaks ☒ **Debris**

debris in channel

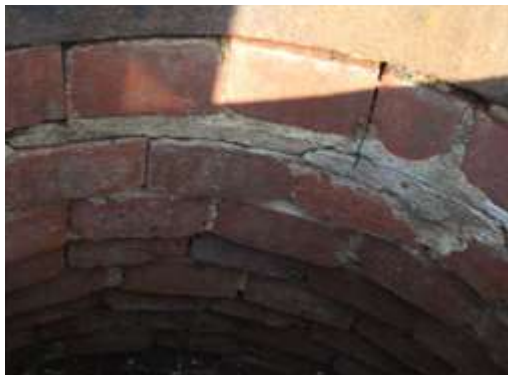
Defect 1

Condition: ☐ Sound ☐ Cracked ☐ Root Intrusion ☒ **Loose Brick** ☐ Deteriorated

missing mortar and loose bricks

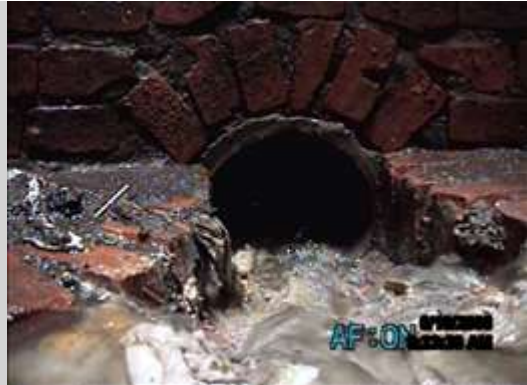
12 O'Clock Outflow

Pipe Height: **8.4** (in.) Rod and Bar (Angled)
Pipe Material: **Clay** ☐ Pipe Lined
Invert Depth: **9.28** (ft.) Flow Characteristics: **Fast**
Deposits: ☐ None ☐ Mud ☐ Sludge ☒ **Debris** ☐ Grease
Silt Depth: **3** (in.) Deposits Extent: **Heavy**
Infiltration: **None** Pipe Seal Cond: **Sound**

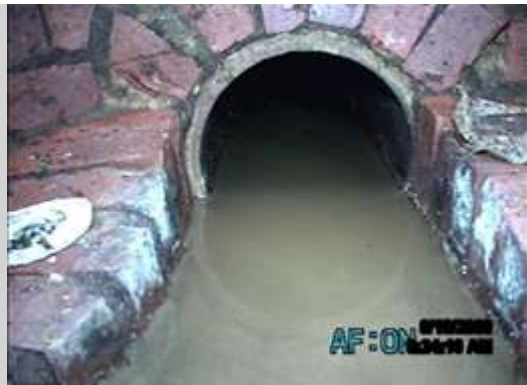
3 O'Clock Inflow

Pipe Height: **8.4** (in.) Rod and Bar (Angled)
Pipe Material: **Clay** ☐ Pipe Lined
Invert Depth: **8.76** (ft.) Flow Characteristics: **Slow**
Deposits: ☐ None ☐ Mud ☐ Sludge ☒ **Debris** ☐ Grease
Silt Depth: **3** (in.) Deposits Extent: **Heavy**
Infiltration: **None** Pipe Seal Cond: **Sound**

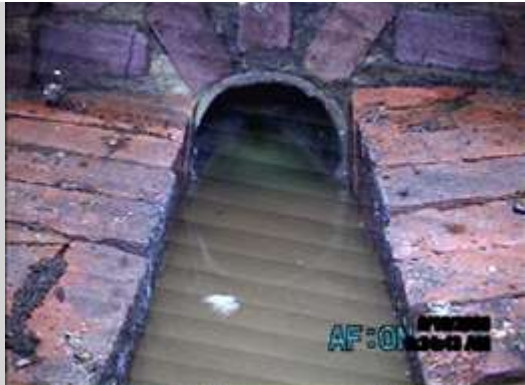
6 O'Clock Inflow

Deposits: ☐ None ☐ Mud ☐ Sludge ☒ **Debris** ☐ Grease

Silt Depth: **3** (in.) Deposits Extent: **Medium**

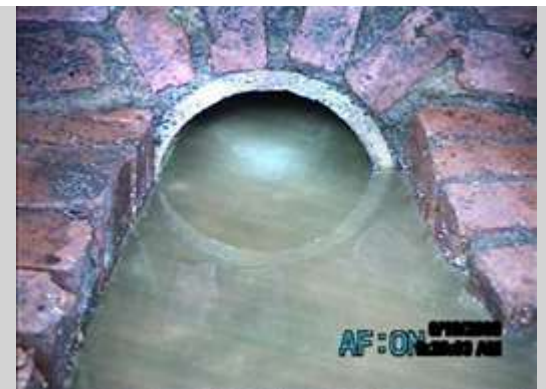
9 O'Clock Inflow

Deposits: ☐ None ☐ Mud ☐ Sludge ☒ **Debris** ☐ Grease

Silt Depth: **3** (in.) Deposits Extent: **Medium**
